# Lessons from Wenchuan 512 for Building Seismic Resilience in China

Paul GRUNDY<sup>1</sup>, Bixiong LI<sup>2</sup>, Qingyuan WANG<sup>3</sup>

<sup>1</sup> Department of Civil Engineering, Monash University  
(paul.grundy@eng.monash.edu.au)

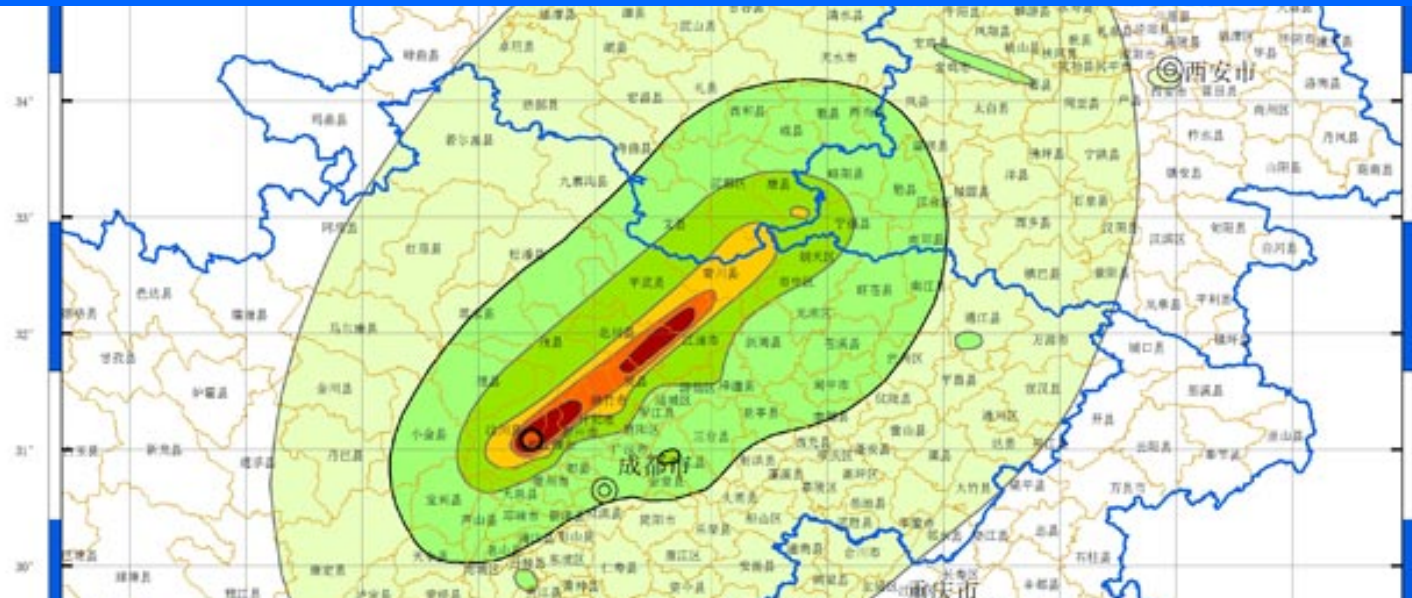
# Estimated Mercalli Intensity - Wenchuan

The area exceeding the design intensity of the Chinese Building Design Code – VII or higher – is 20,000 km<sup>2</sup>, approximately 0.2% of the area of China

The area experiencing intensity greater than V – with potential to cause damage – is ~350,000 km<sup>2</sup>, approximately 3.6% of the area of China

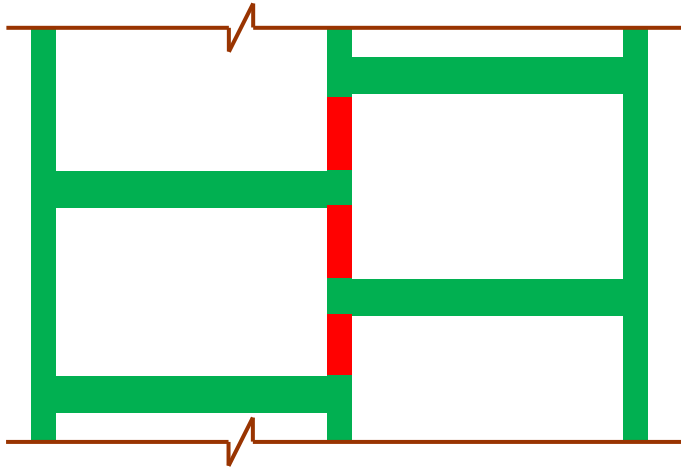
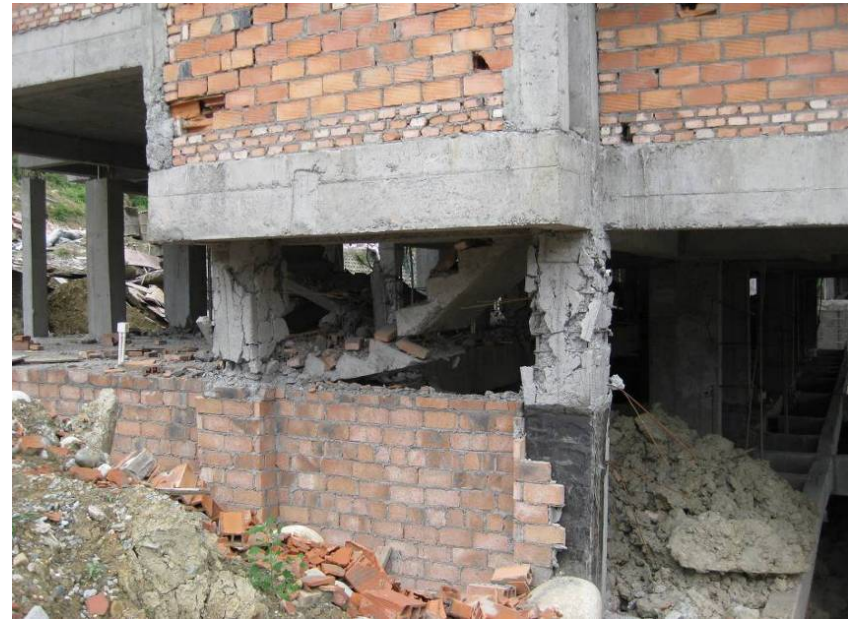
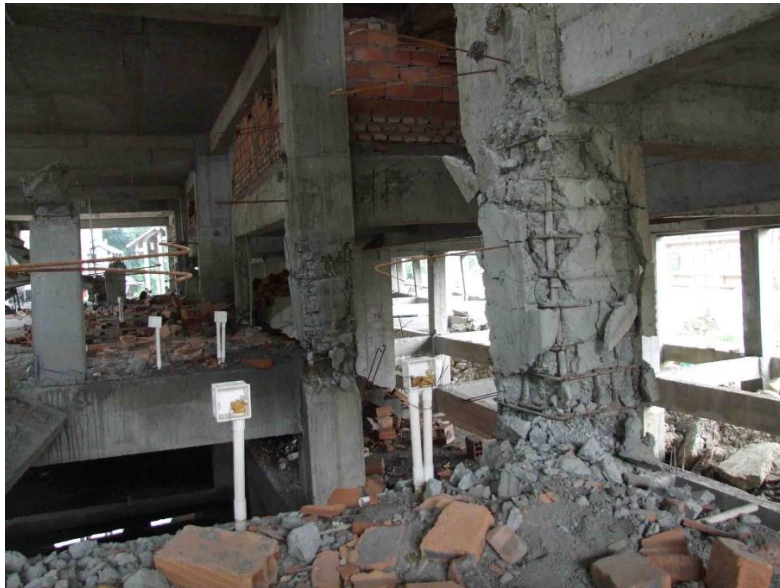
# Short columns attracting shear

短柱 = 剪力大

1. 'Strong beam – weak column' instead of 'weak beam – strong column'
2. Soft storey
3. Short columns attracting shear
4. L- and T-shaped floor plans instead of rectangular
5. Pounding of adjacent buildings
6. Staircases not integrated into seismic resistance

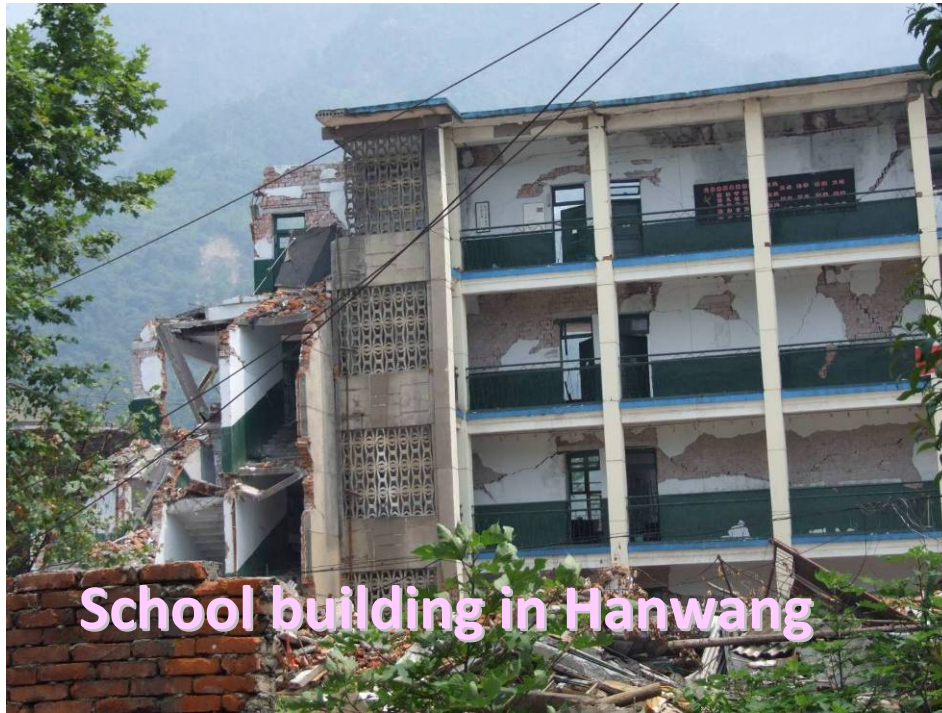
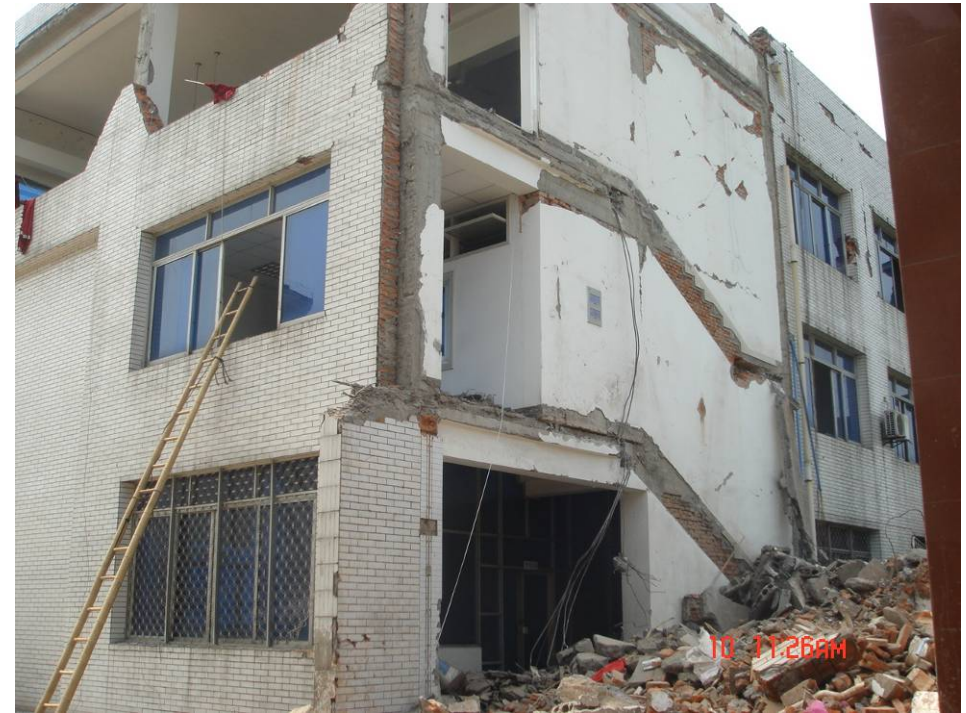
# Performance of staircases

The staircase collapsed during the earthquake. Many students lost their lives in the stairwell, while the main structure stood. Staircases were designed for gravity loads only, not seismic forces.

楼梯的破坏

楼梯破坏的原因

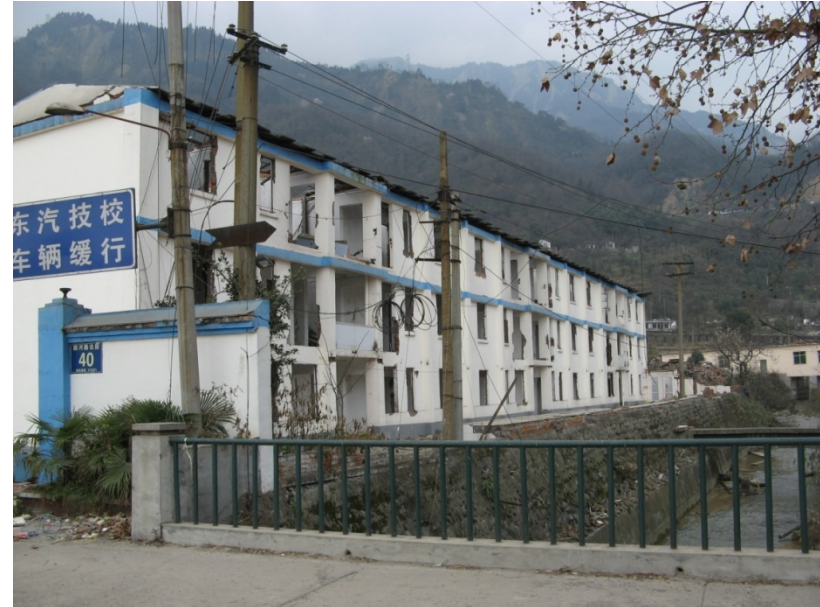
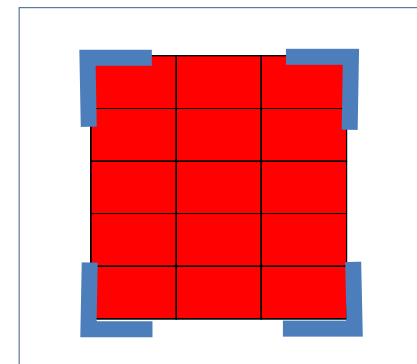
# Masonry confined by steel – an Example of Ductility

100m from fault at Hanwang  
Building stands while others  
around collapse

Masonry columns reinforced  
with tied corner steel angles  
make the structure ductile

**Brittle structures can be made ductile  
and earthquake resistant!**

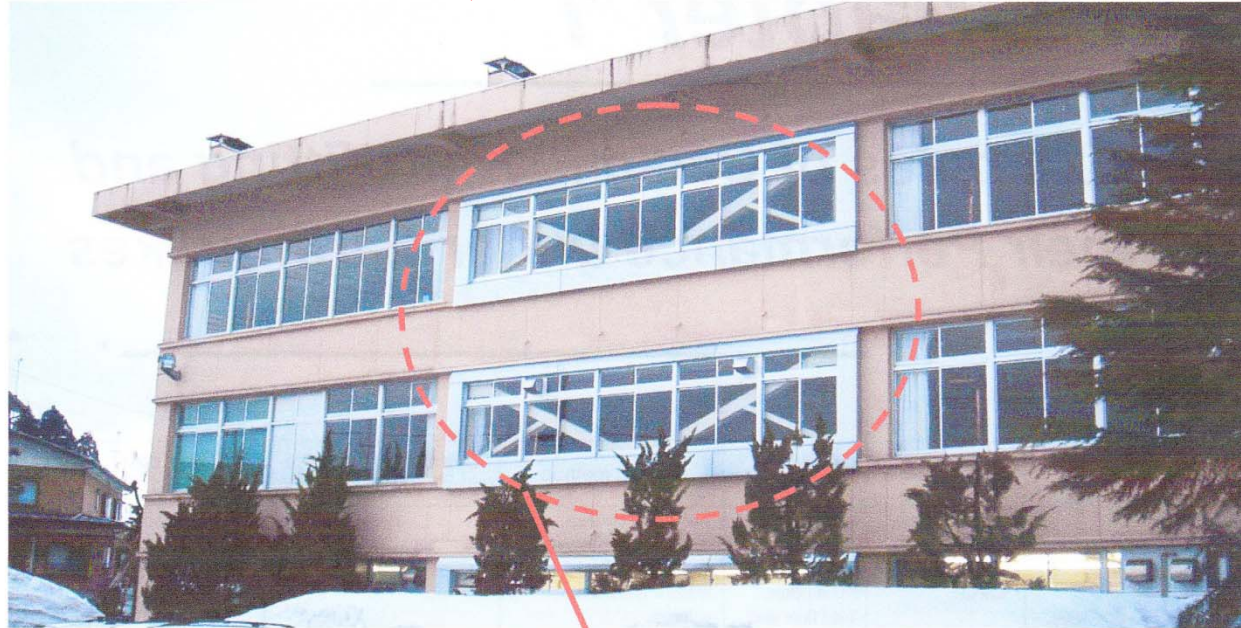
# Japanese Retrofit Examples

After retrofit (outside view)

Steel bracings (diagonal)

Wall girder

Before retrofit (outside view)

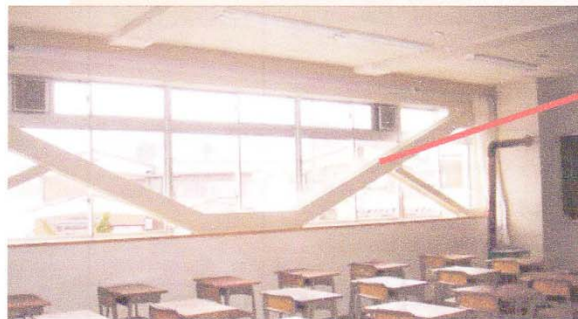
After retrofit (Inside view)
